Debris/Ice/TPS Assessment And Integrated Photographic Analysis For Shuttle Mission STS-47

November 1992

DEBRIS/ICE/TPS ASSESSMENT
AND
PHOTOGRAPHIC ANALYSIS
OF
SHUTTLE MISSION STS-47

September 12, 1992

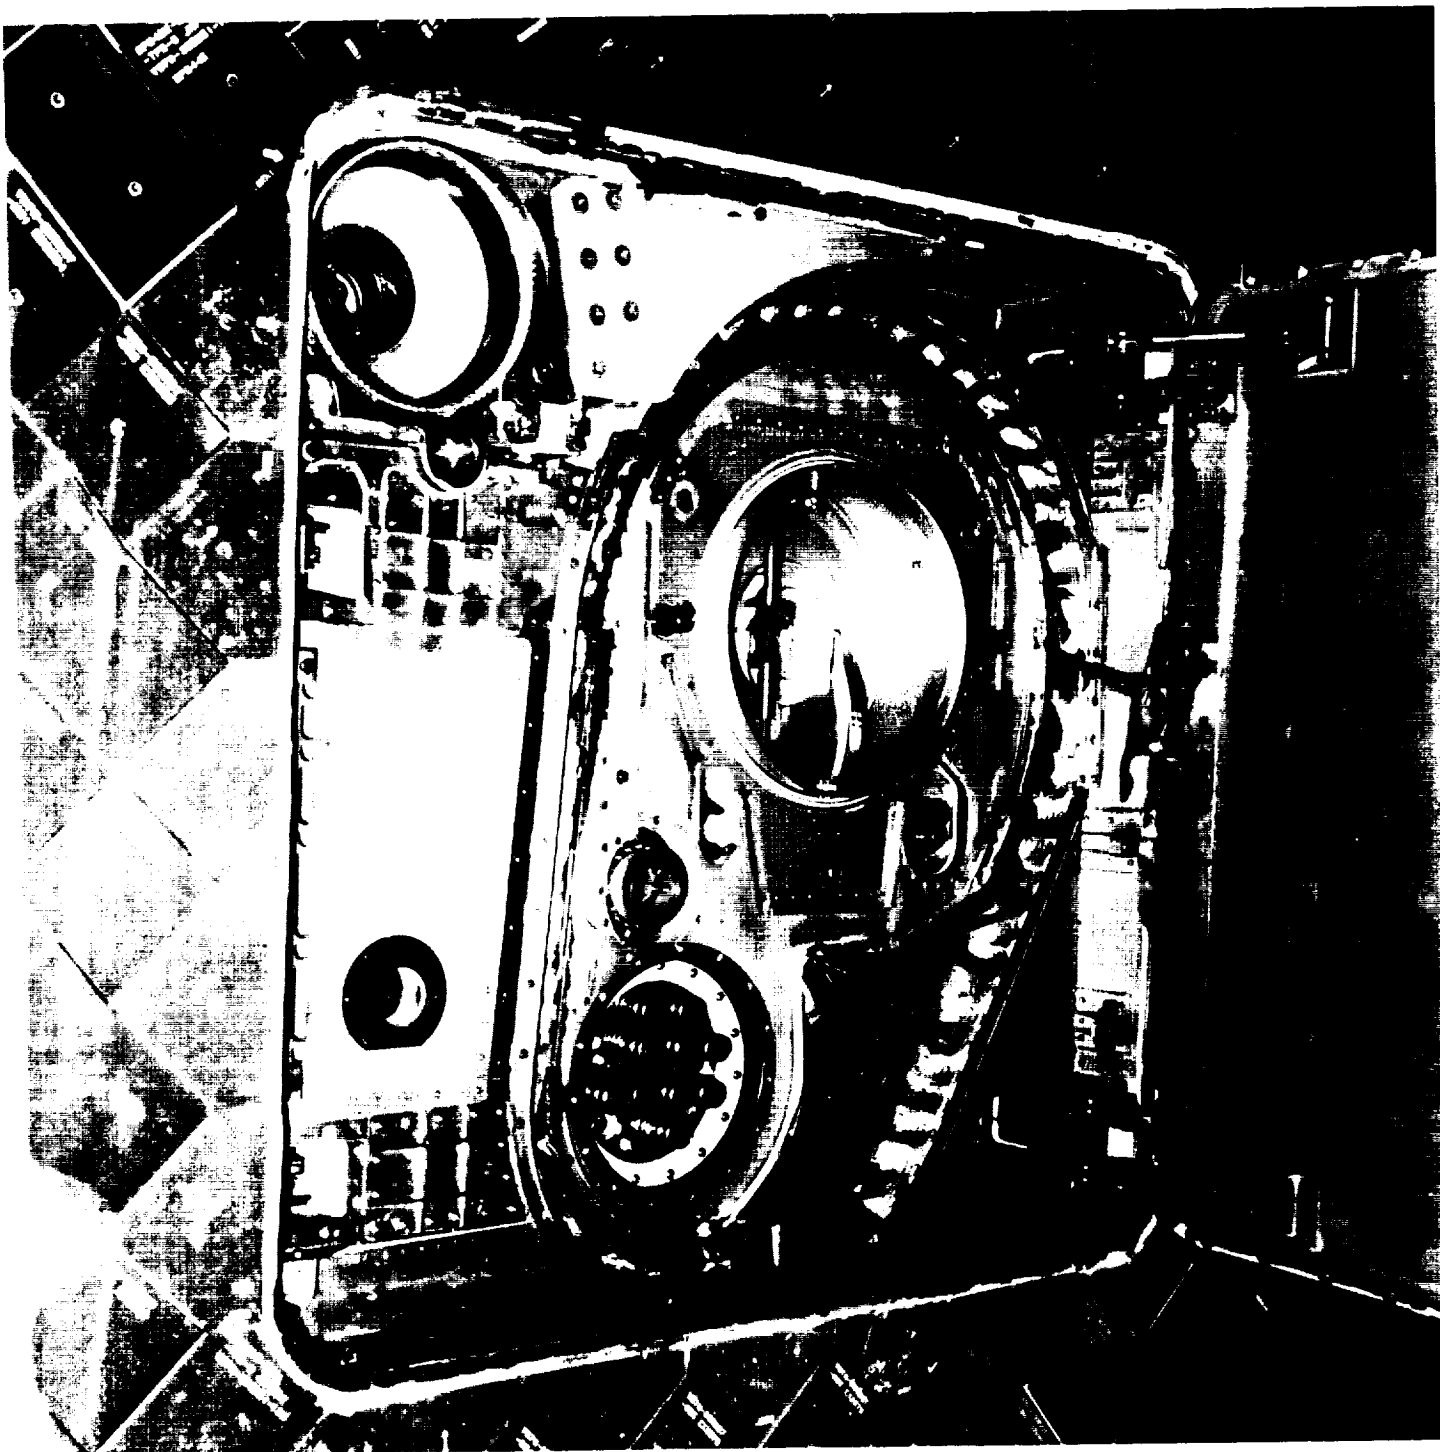
Overall view of the LO2 ET/ORB umbilical. No flight hardware was found on the runway below the umbilical when the ET door was opened.

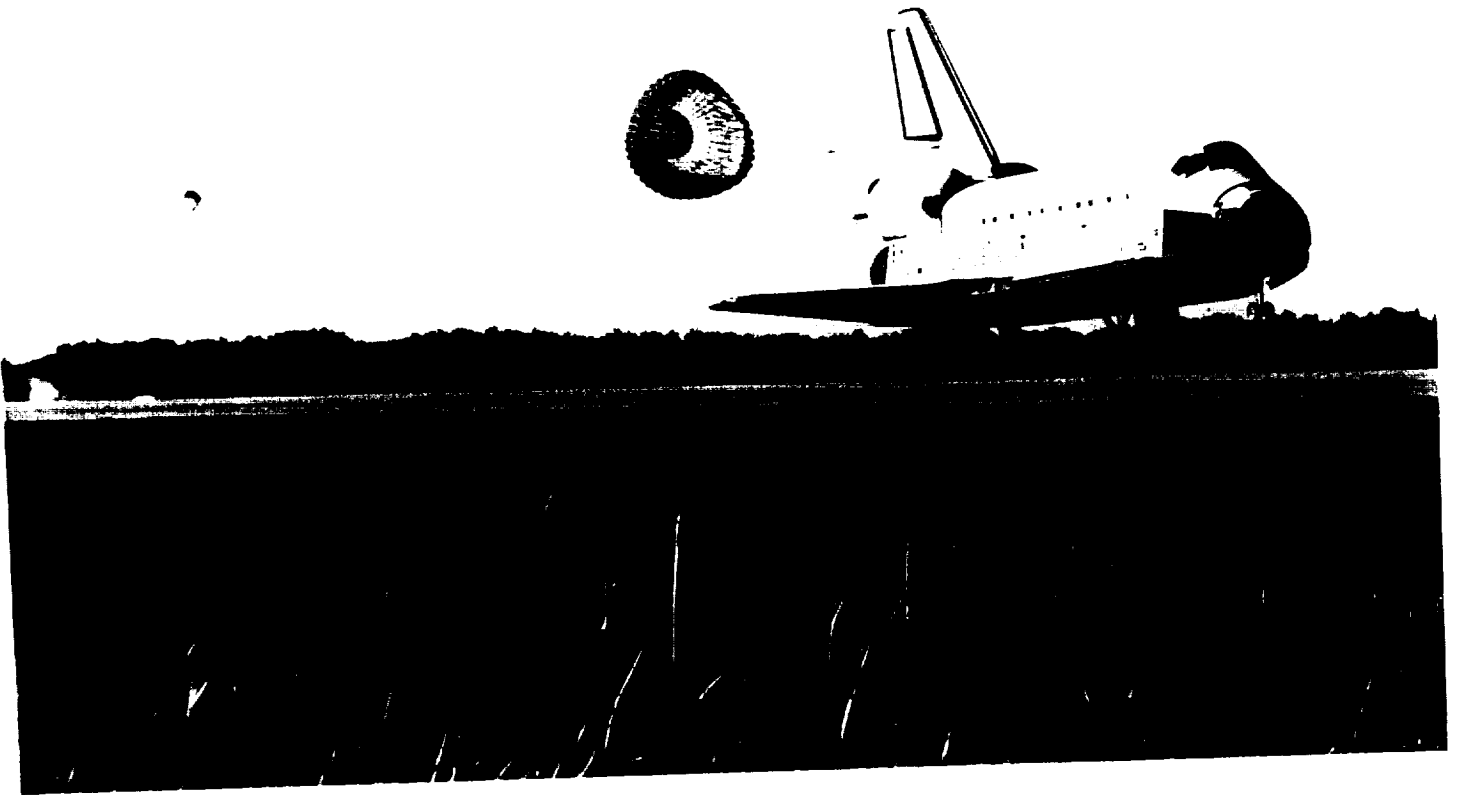
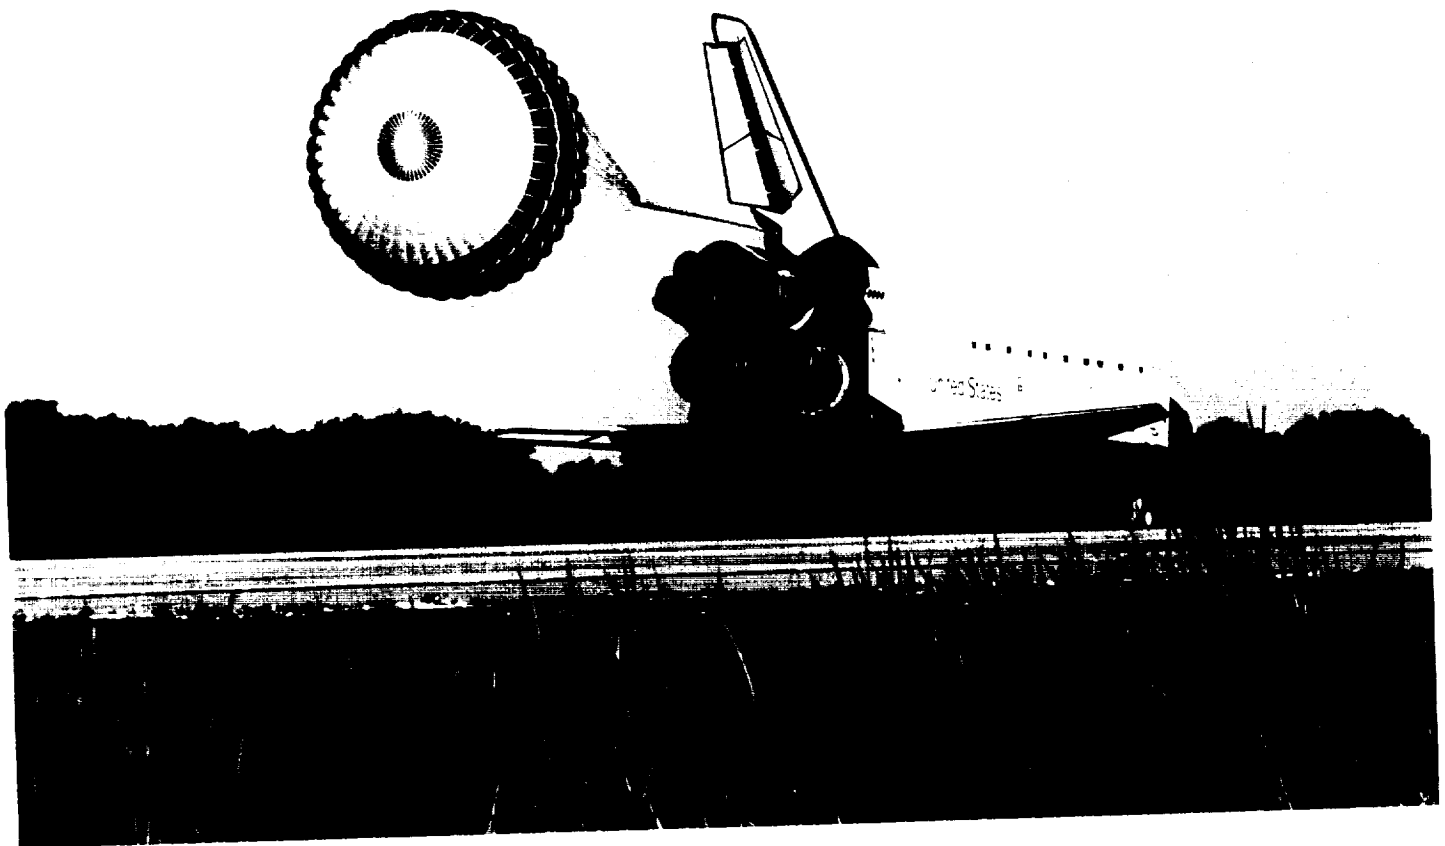
Inspection of Runway 33 immediately after landing revealed numerous pieces of tile material from the vertical stabilizer "stinger" and a piece of red RTV material from the RH outboard main landing gear tire pressure instrumentation cable.
